# TECHNICAL BULLETIN

PRIMAAX® EX • PRIMAAX®  
FIREMAAX® EX • FIREMAAX®

**SUBJECT:** Pivot Bushing and D-Pin Bushing  
Inspection

**LIT NO:** SEU-0235

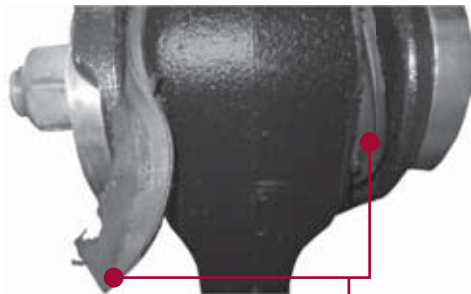
FIGURE 1

- The support beam is designed with the pivot bushing centered in the support beam end hub. If the pivot bushing is not centered in the end hub, it is an indication that the pivot bushing could be worn and a pivot bushing physical inspection is required.
- If the pivot bushing shows signs of torn, separated or disconnected rubber, see Figures 1 and 2, this could be a result of axle misalignment. If this condition is evident, a pivot bushing physical inspection is required.
- If the outer rubber flange(s) is missing, or there are shards of rubber visible, see Figure 3, this could be a result of axle misalignment. If this condition is evident, pivot bushing replacement is required.

Torn Rubber

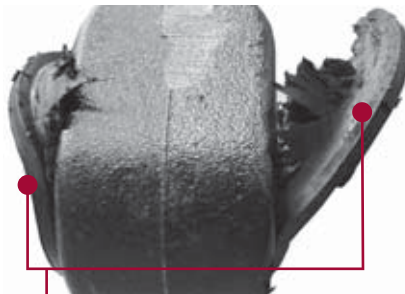
FIGURE 2

Disconnected Rubber Flange

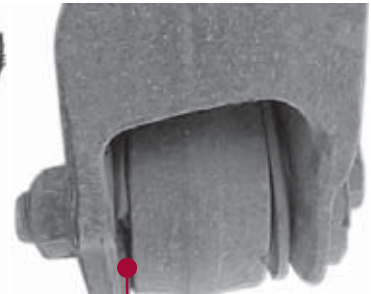
FIGURE 3

Missing Rubber Flange

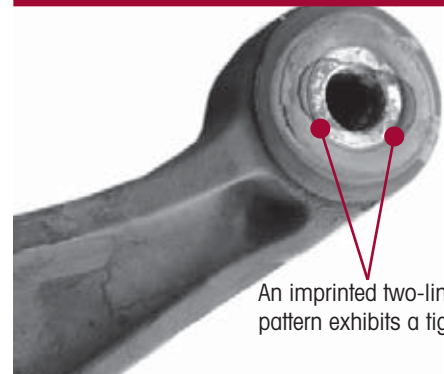
FIGURE 4

3. No replacement is needed if the bushing exhibits a tight joint, see Figure 4. An imprinted two-line wear pattern on the bushing inner metal indicates the pivot bushing is securely clamped in the hanger.

### GOOD JOINT - NO REPLACEMENT NEEDED

An imprinted two-line wear pattern exhibits a tight joint

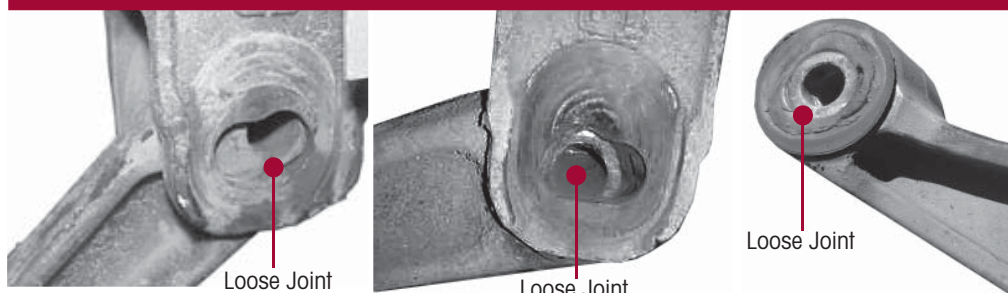
FIGURE 5

4. Inspect pivot bushing, replacement is necessary if any indications of the following are apparent, see Figure 5:
  - Signs of rust, distorted, separated or torn rubber, elongated or damaged bore. This could be a result of axle misalignment or loose fasteners.

### INSPECT FOR INDICATIONS OF A LOOSE JOINT

Loose Joint

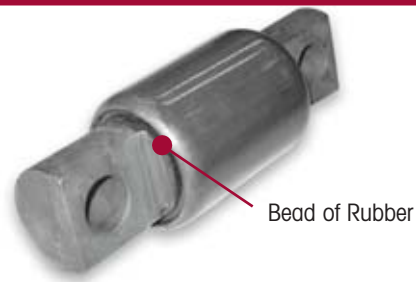
**FIGURE 6**

The D-Pin bushing is designed with a layer of rubber in the bushing, it is acceptable to see a bead of rubber protruding from the bushing, see Figure 6.

### ACCEPTABLE D-PIN

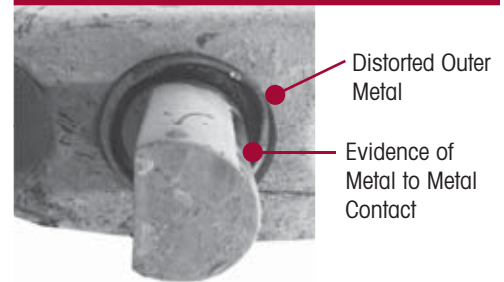
**FIGURE 7**

- Metal to metal contact wear marks on the D-pin outer metal are evident, see Figure 7.
- D-pin outer metal is distorted, see Figure 7.

### UNACCEPTABLE D-PIN

Refer to the D-Pin Component Replacement Section in the appropriate Hendrickson PRIMAAX EX • PRIMAAX • FIREMAAX EX • FIREMAAX suspension Technical Procedure manual.
