# TECHNICAL PROCEDURE VANTRAAX® ULTRAA-K®

**SUBJECT:** Frame Bracket  
Pierced Alignment Guide Repair

**LIT NO:** T82004

**DATE:** October 2015

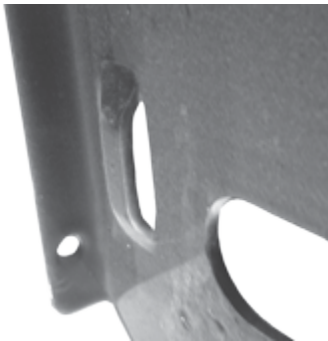
Normal

For VANTRAAX® ULTRAA-K® sliders, the QUIK-ALIGN® alignment guides are fabricated by piercing the metal, as shown above. In the event of an impact (e.g. tires hitting an immovable object), the forces may be strong enough to move the alignment collars. Should this happen, the pierced alignment guide may be damaged.
